DEPARTMENT OF NATURAL RESOURCES
DIVISION OF OIL, GAS AND MINING

SUBJECT: Site Inspection, Emery Industrial Resources, Cherry Hill Park Mine, M/049/021, Utah County, Utah

Date of Inspection: August 7, 2003
Time of Inspection: About 8:50 to 9:10 a.m.
Conditions: Mostly clear, 80's
Participants: Wayne Hedberg, Doug Jensen, Joelle Burns, and Paul Baker, DOGM

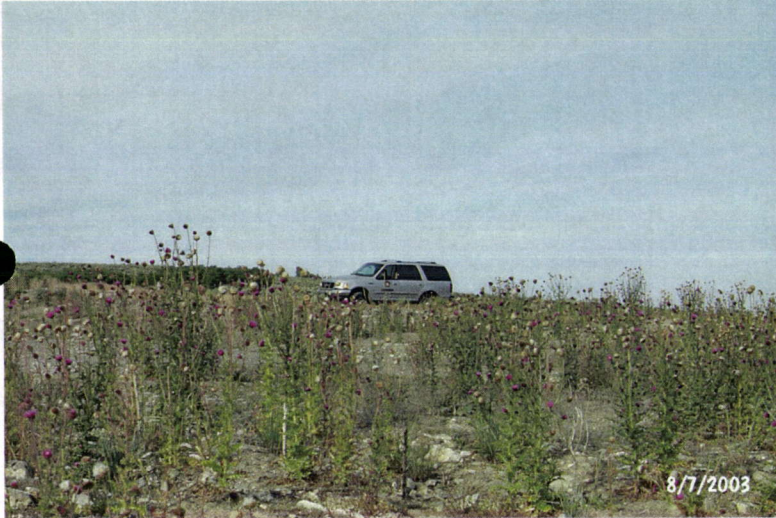
We saw no evidence of any recent regrading activities. Comparing photos from the May 9, 2003, inspection with current conditions, the major differences were that the musk thistle was now apparent and that there was now a piece of screening equipment on site. The Division has previously noted musk thistle at this site and had advised the operator that it should be controlled. Musk thistle is shown in Photos 1 through 3. We found one small area near the screening equipment where it appeared some of the musk thistle had been pulled but found no other evidence of control efforts. The musk thistle seemed to be concentrated in the southern part of the site, but there were plants in every area of the mine.

Photo 1. Some of the musk thistle in the south part of the mine site.

The operator needs to attempt to control musk thistle on the site. This noxious weed is likely to cause problems with revegetation and may spread to surrounding areas.

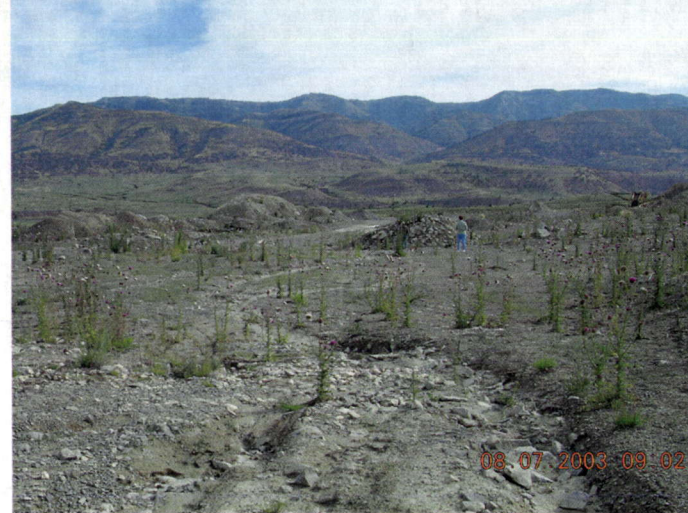
Photos 2 through 4 show erosion rilling in the south part of the disturbed area. We did not find evidence that sediment was causing degradation of water off the site.

Photo 3. Another view of erosion.

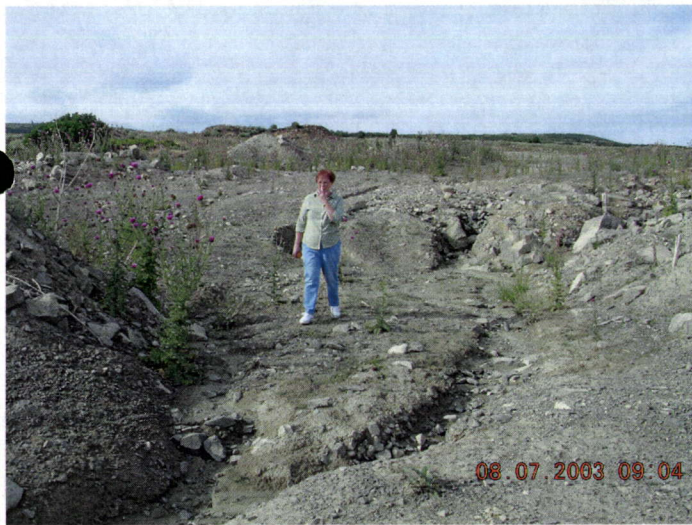
Photo 2. Rills and musk thistle in the south part of the mine site.

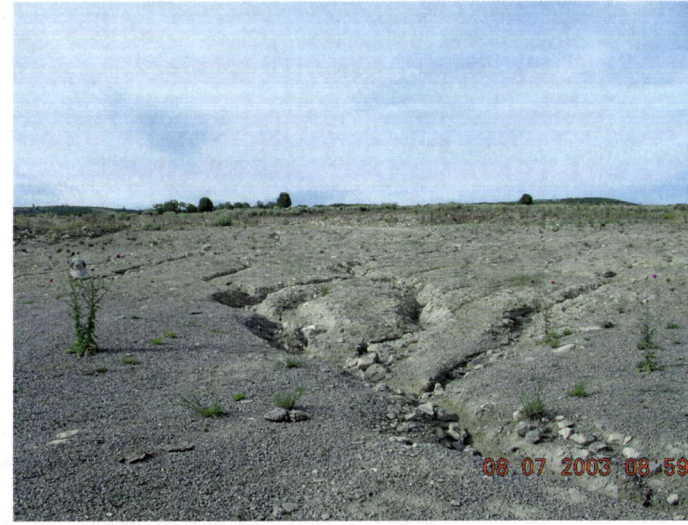
Photo 4. Another view of erosion damage.

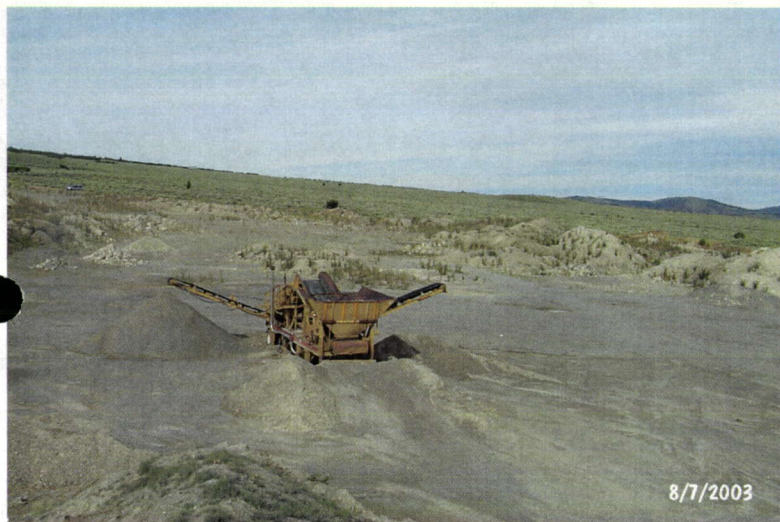
Photos 5 through 7 show the screening equipment and some of the piles at the end of the conveyors. Photo 8 is a stockpile from which it appears someone has recently taken material, possibly to feed into the conveyor.

It appears the operator has processed a small amount of material through the screening equipment since the Division's May 9, 2003, inspection. This inspection was done prior to the Board hearing where the operator's notice of intention was withdrawn and was ordered to cease mining operations.

Photo 5. Screening equipment in the northern part of the mine area.

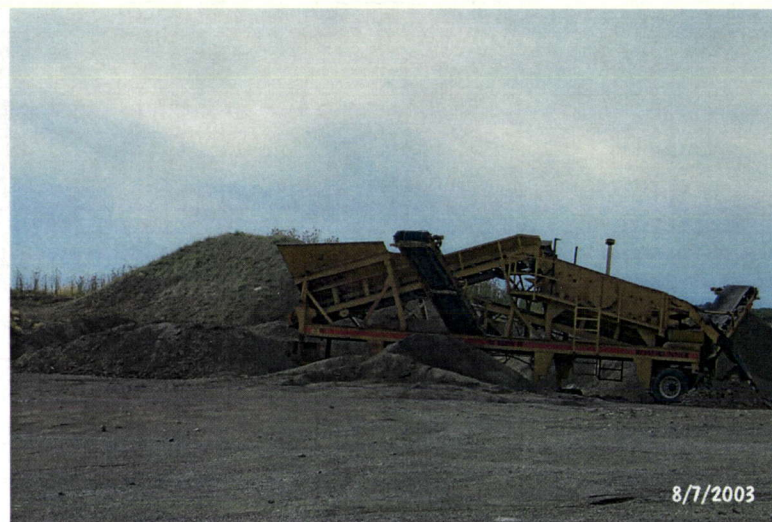
Photo 7. One more view of the screening equipment.

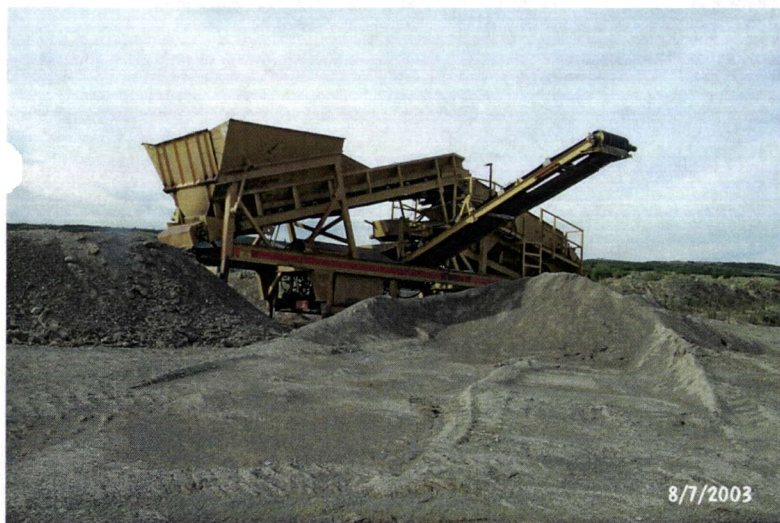
Photo 6. Another view of the screening equipment and piles of screened material.

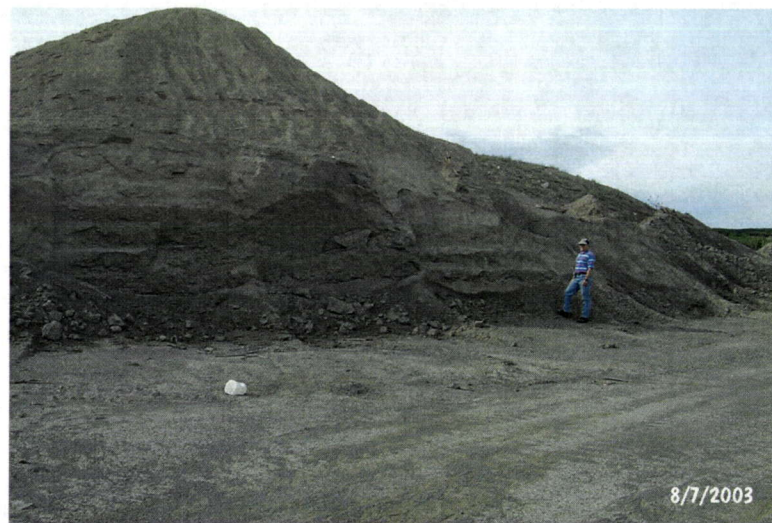
Photo 8. A stockpile near the screening equipment from which it appeared material had been taken recently.

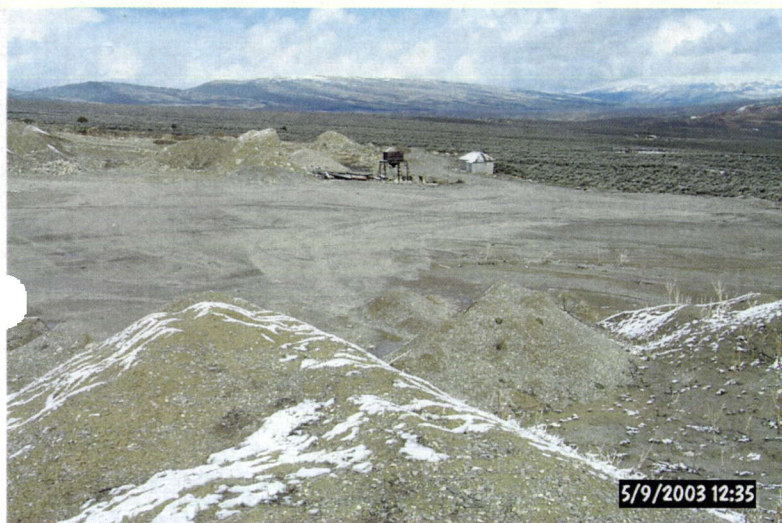
Photos 9 and 10 were taken during the May 9, 2003 inspection and correspond approximately to the areas shown in Photos 11 and 12. The major change is the screening equipment.

Photo 9. Picture taken during the May 9, 2003, inspection in the northern part of the disturbed area. Compare with photo 11.

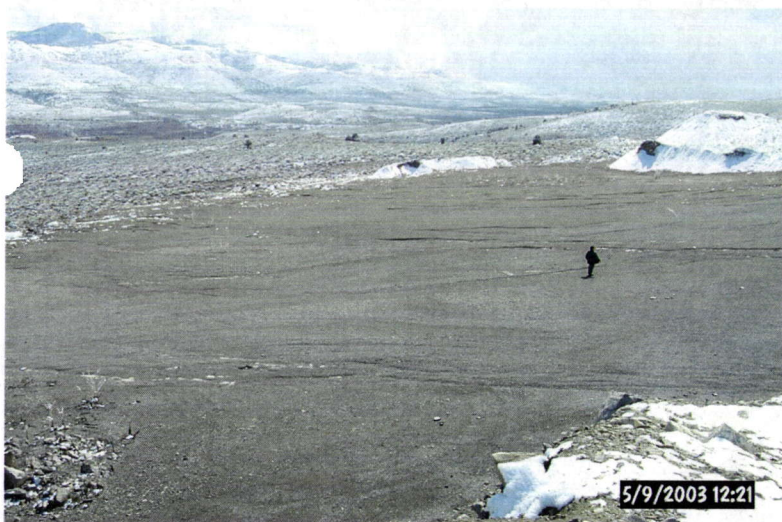
Photo 10. A pad in the northern part of the disturbed area corresponding approximately with the area shown in Photo 12.

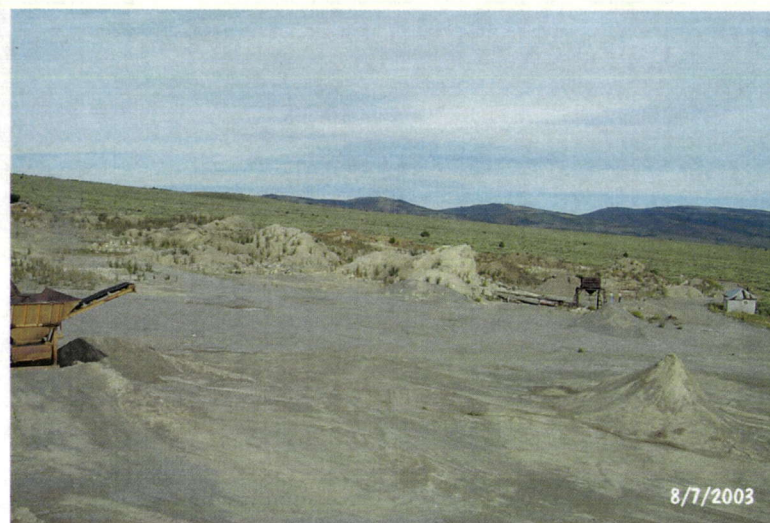
Photo 11. The screening equipment on the left and an old screen and building (not part of the disturbed area) in the right center.

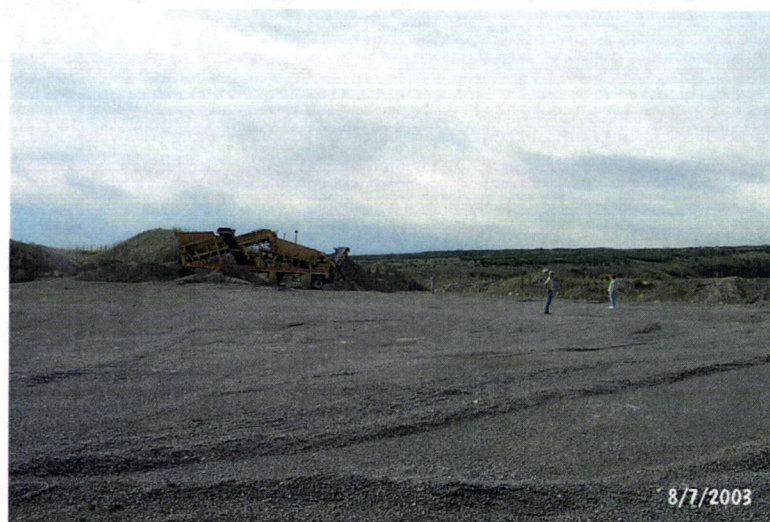
Photo 12. Another view of the flat area near the screening equipment.
